# Inadvertent Transarterial Temporary Pacemaker Lead Placement: An Unusual Complication

## Case Report

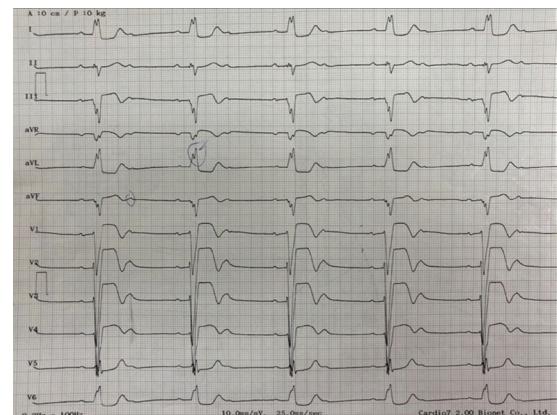
We report the case of a 77-year-old male who underwent temporary pacemaker lead implantation after a symptomatic 2:1 Mobitz type II second-degree block and left bundle branch block conduction (Figure 1). The temporary pacemaker was implanted apparently through the right jugular vein without fluoroscopic guidance, only by monitor guidance. After medical stabilization the patient was referred to our tertiary care center for further management. A cardiovascular system examination was unremarkable. Electrocardiogram showed a paced left bundle branch block pattern; however, with

**Figure 1.** Initial electrocardiogram with 2:1 Mobitz type II second-degree block and left bundle branch block conduction.

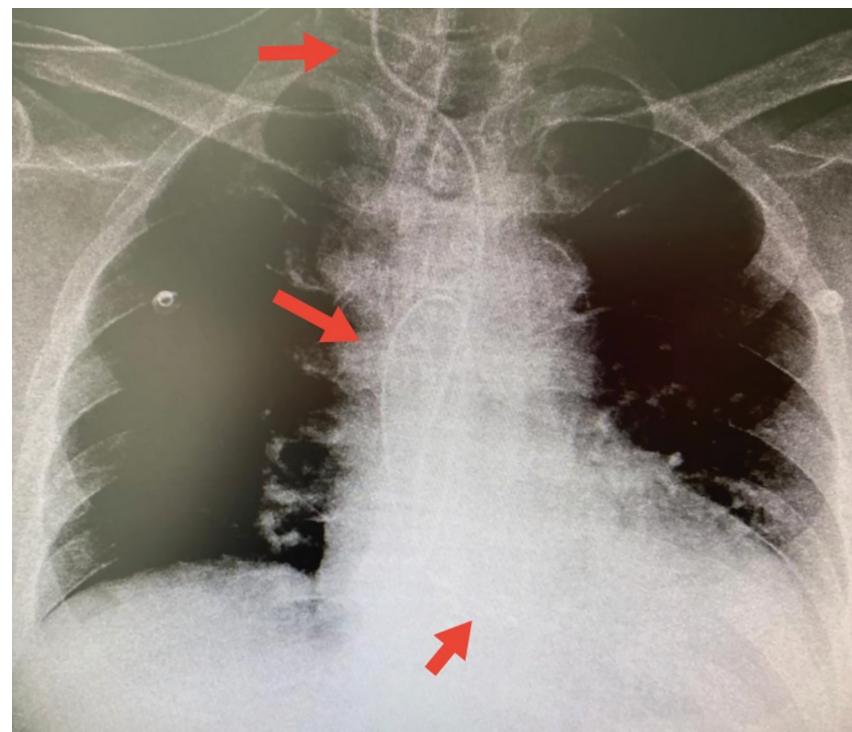
a high threshold stimulation level. The x-ray showed an abnormal lead path (Figure 2). A computed tomography angiography was performed that documented an intra-arterial lead with entry into the right common carotid artery and with the tip crossing the aortic valve and ending in the left ventricular outflow tract (Figure 3). Removal of the lead and relocation of the temporary pacemaker was requested by interventional cardiology. The fluoroscopy showed a temporary pacemaker lead with an arterial course with a loop in the ascending aorta and the tip crossing the aortic valve (Figure 4). A puncture of the right common femoral vein was performed, and a 6 French introducer sheath was placed. The temporary pacemaker lead was advanced to the right ventricle (Figure 5). The intra-arterial lead was removed and an angiogram was performed through the introducer sheath, confirming the arterial site (Figure 6). The introducer sheath was subsequently removed without complications.

**Figure 2.** X-ray showed an abnormal lead path.

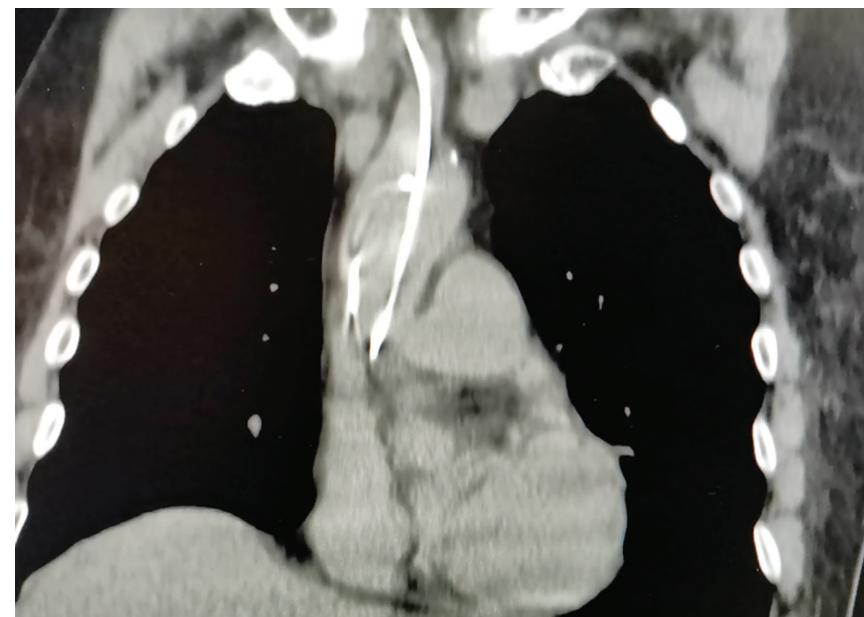
**Figure 3, Video 1** (online with the article at [CathLabDigest.com](http://CathLabDigest.com)). A computed tomography scan documented an intra-arterial lead with entry into the right common carotid artery, with the tip crossing the aortic valve and ending in the left ventricular outflow tract.

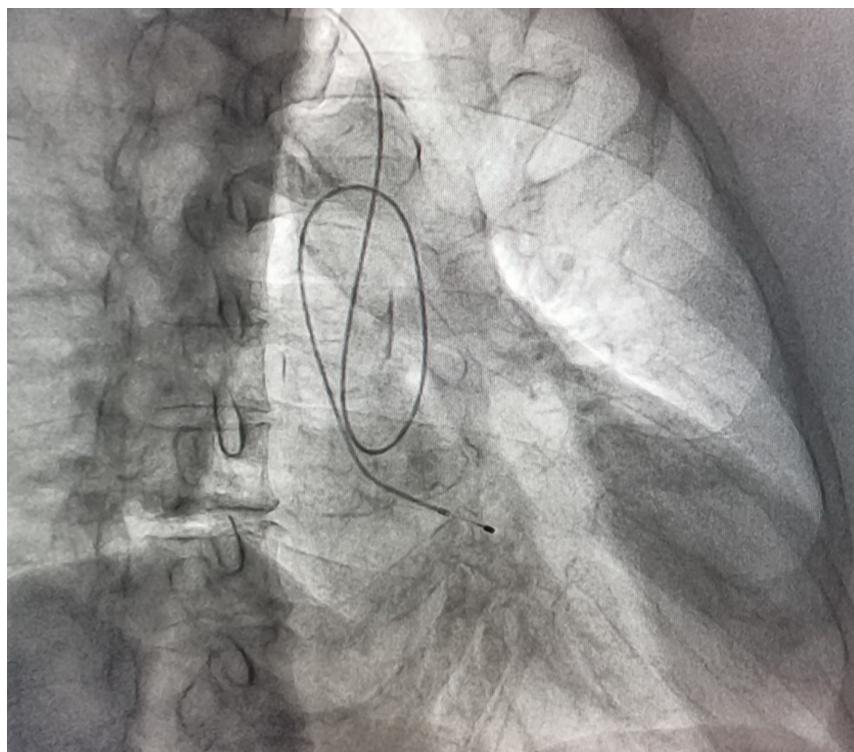
**Figure 4.** The fluoroscopy showed a temporary pacemaker lead in an arterial course with a loop in the ascending aorta and the tip crossing the aortic valve.

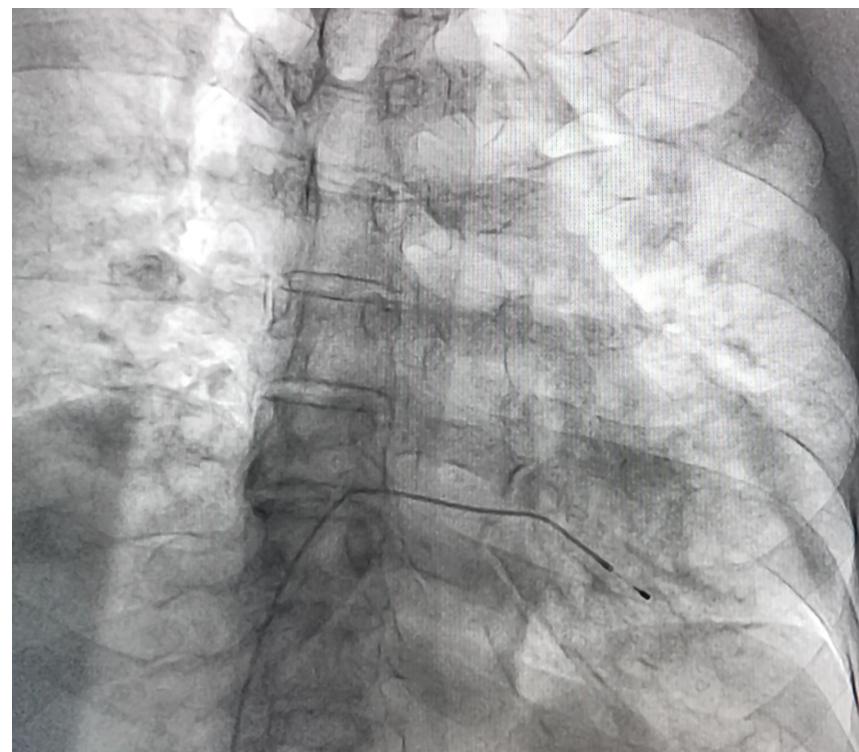
**Figure 5.** Adequate lead placement in the right ventricle.

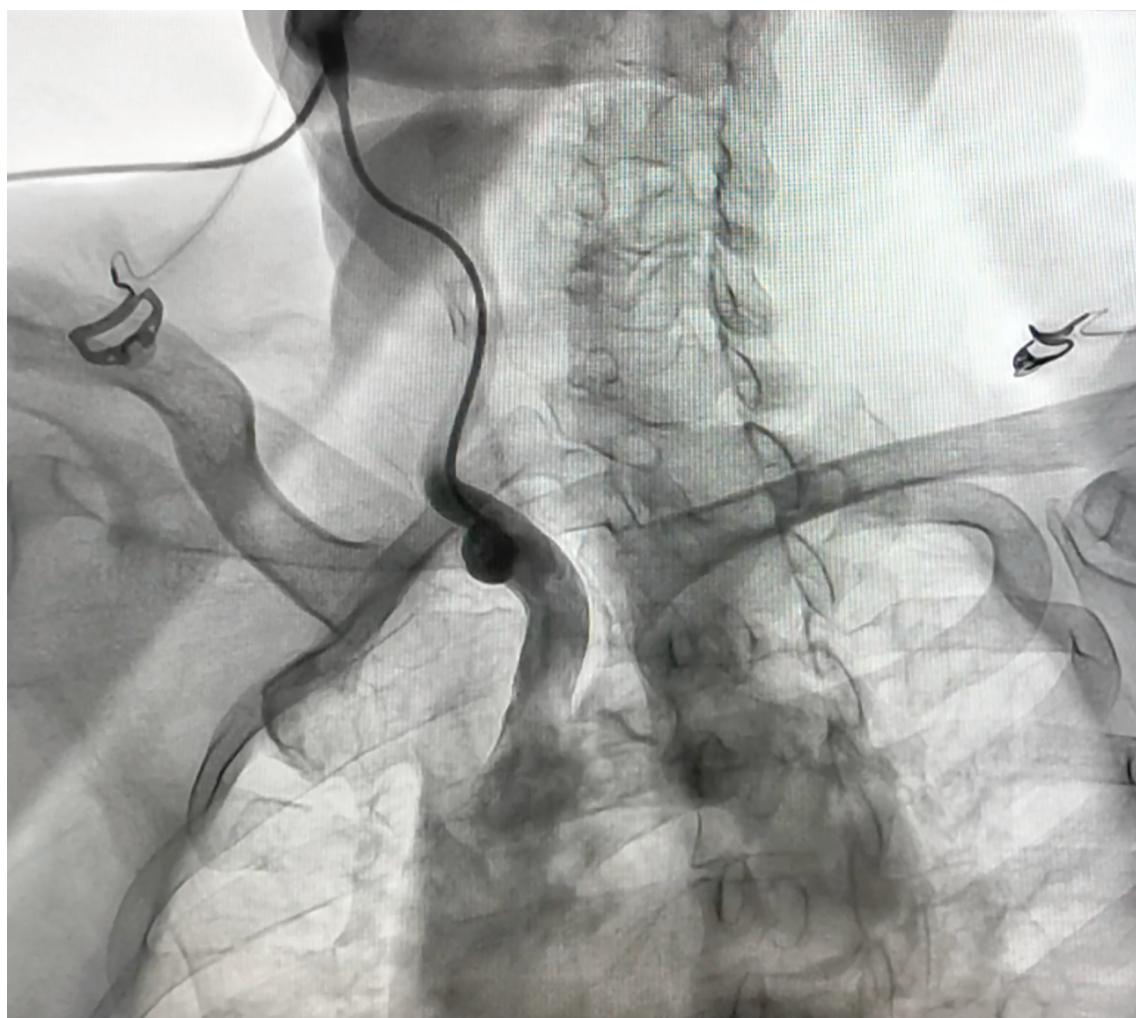
**Figure 6, Video 2 (online with the article at CathLabDigest.com).** Angiogram through the introducer sheath confirming the arterial site.
