The Invisible Revealed: The Importance of IVUS in Diagnosing and Treating a Coronary Wire Complication

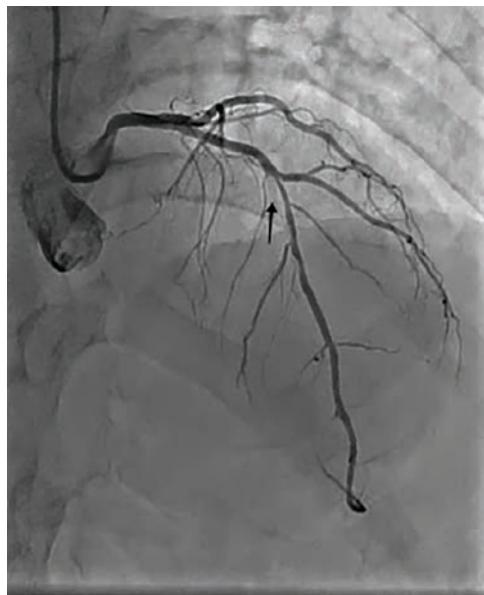
Figure 1. Angiographic image showing stenotic lesion (black arrow) in the left anterior descending (LAD) coronary artery.

A 72-year-old male underwent elective percutaneous coronary intervention (PCI) for a significant stenotic lesion in the left anterior descending (LAD) artery (Figure 1 white arrow, Video 1).

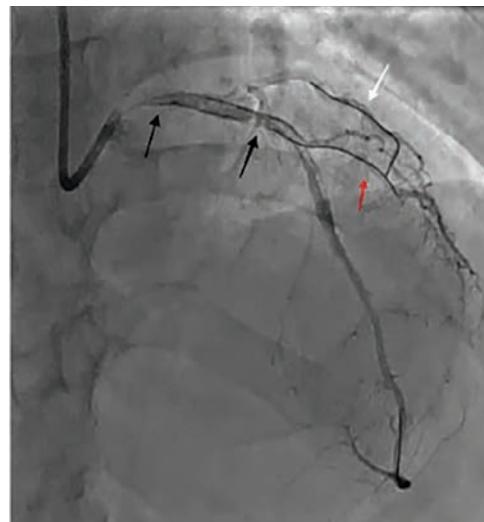
Figure 2. Fractured wire entrapped behind stent struts (black arrow). Retained wire fragment visualized in diagonal branch (red arrow). A supportive parallel wire in the left circumflex (LCX) (white arrow).

However, a radiopaque segment remained within the side branch, while the remaining wire fractured and became entrapped behind the stent struts (Figure 2 [black arrows], Video 2).

Final angiography confirmed TIMI-3 flow with no dissection, perforation, or distal embolization; the wire in the side branch remained in place at the end of the procedure (Figures 2 [white arrow], 4A-C, 5, Video 6).

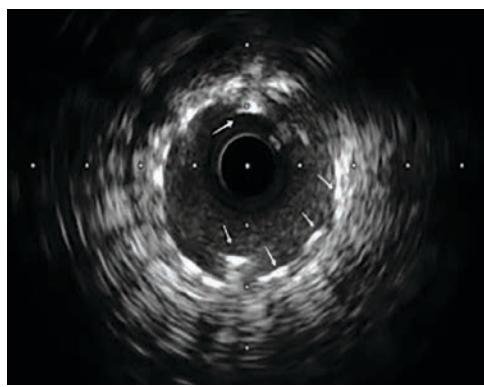
Figure 3A. Intravascular ultrasound (IVUS) showing wire loop near proximal LAD (white arrows).

A coronary snare was used to retrieve the proximal segment of the retained wire. Partial extraction was achieved, but tangled wire fragments remained lodged in the proximal LAD. To stabilize these remnants, an additional DES was deployed to pin the wire against the vessel wall. Although angiography initially appeared satisfactory, intravascular ultrasound (OptiCross, Boston Scientific) proved pivotal by revealing that the wire loops had coiled within the stent, extended retrogradely into the proximal LAD, and reentered the stented segment near the left main stem (LMS) (Figures 2 [red arrow], 3A-C, Video 3).

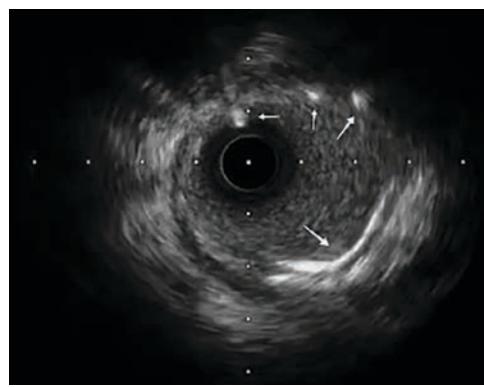
Figure 3B. IVUS showing wire loops in left main (LM) proximal to stent edge (white arrows).

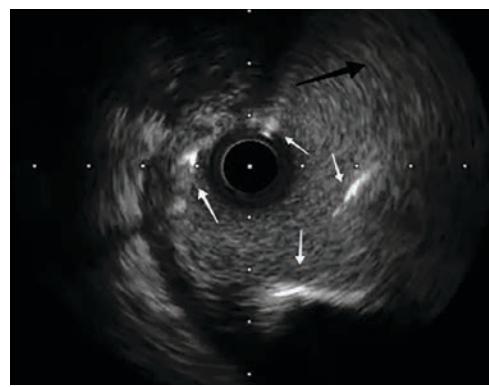
Figure 3C. IVUS showing retrograde extension of wire into the left main stem (LMS) (white arrows). Aorta can be seen at the black arrow.

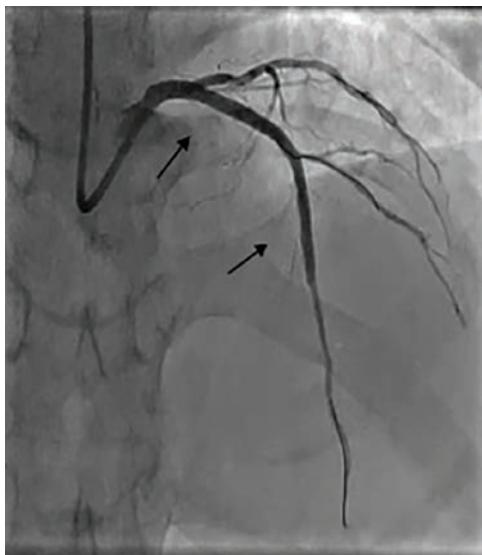
Figure 5. Angiographic image showing final results (black arrow).
